AIRWORTHINESS DIRECTIVE

No. 2019-322-02

Effectivity - RRJ-95 aircraft

TECHNICAL DECISION RRJ0000-OR-470-3080

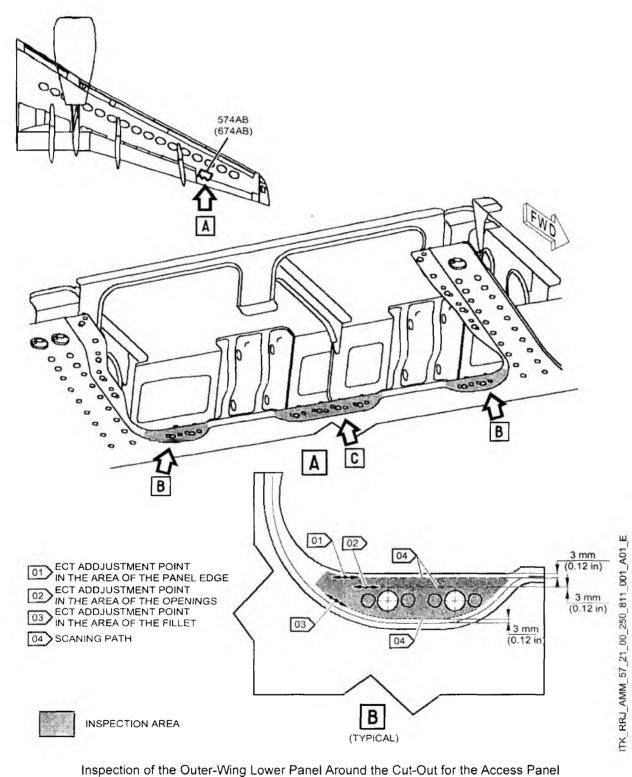
Figure 501 (Sheet 1 of 2)

The present inspection procedure is intended for detection of fatigue cracks on the outer-wing lower panel in the area of the cut-outs for the access panels 574AB and 674AB (Ref. *Fig. 501, Sheet 1*, *Fig. 501, Sheet 2*).

- A. Eddy current inspection of the bracket lugs surface shall be done in the following areas (Ref. *Fig. 501, Sheet 1, Fig. 501, Sheet 2*):
 - lower panel edge area (areas 1, 5);
 - edge area of the openings (areas 2, 6);
 - edge area of the fillet (areas 3, 7);
- 5. <u>Material</u>
 - A. Lower panel material 1163T 18 TV 1-92-161-90 (cyrillic).
 - B. Coating --- Primer 3II-0215 (cyrillic). Paint-coating thickness 0.15-0.2 mm.
- 6. <u>Description of Detectable Flaws</u>
 - A. Fatigue surface cracks with the length of more than 5 mm (0.2 in).

(2) Install the ECT on the coating in inspection area 1 within 3 mm (0,12 in) from the edge of the panel (Ref. *Fig. 501, Sheet 1*).

- (4) If the ECT signal exceeds the set AFI level (rejection level) and the AFI actuate, it shall be identified as a crack.
- (5) Evaluate the conditional length of detected cracks (Ref. NDT 51-66-02).
- (6) Mark the detected cracks.
- (7) Upon completion of the inspection, check the flaw detector adjustment (para. 10.C).
- G. Repeat the operations specified in Paras11.A (1) 11.F (7) for the second outer-wing.
 - <u>NOTE:</u> If there is a suspicion of a crack, repeat the inspection of the indicated areas from the inside of the panel. If it is necessary to access the inner side of the bottom panel, dismantle the harnesses in the inspection area according to the WDM (*Ref. WDM 20-40-60*).
- 12. Rejection Criteria
 - A. Cracks are not acceptable.
- 13. Job Close-Up
 - A. None.

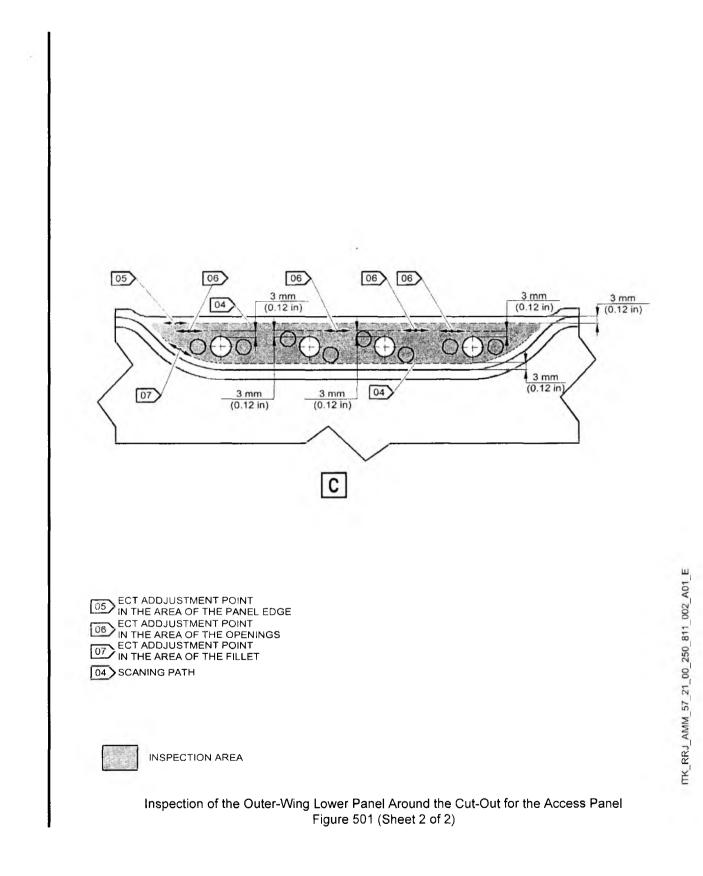
- (4) If the ECT signal exceeds the set AFI level (rejection level) and the AFI actuate, it shall be identified as a crack.
- (5) Evaluate the conditional length of detected cracks (Ref. NDT 51-66-02).
- (6) Mark the detected cracks.
- (7) Upon completion of the inspection, check the flaw detector adjustment (para. 10.C).
- (8) Repeat the operations specified in Paras11.C (1-7) for the second cut-out in the area 3 (Ref. *Fig. 501, Sheet 1*).
- D. Inspection of area 5
 - (1) Adjust the flaw detector according to Paras 10.A-C.
 - (2) Install the ECT on the coating in inspection area 5within 3 mm (0,12 in) from the edge of the panel (Ref. *Fig. 501, Sheet 2*).

- (1) Adjust the flaw detector according to Paras 10.A-C.
- (2) Install the ECT on the coating in inspection area 7 within 3 mm (0,12 in) from the edge of the fillet (Ref. *Fig. 501, Sheet 2*).
