Technical Decision RRJ0000-OR-053-0016

on checking the longitudinal strut rods in Section F5 on the RRJ-95 type aeroplane

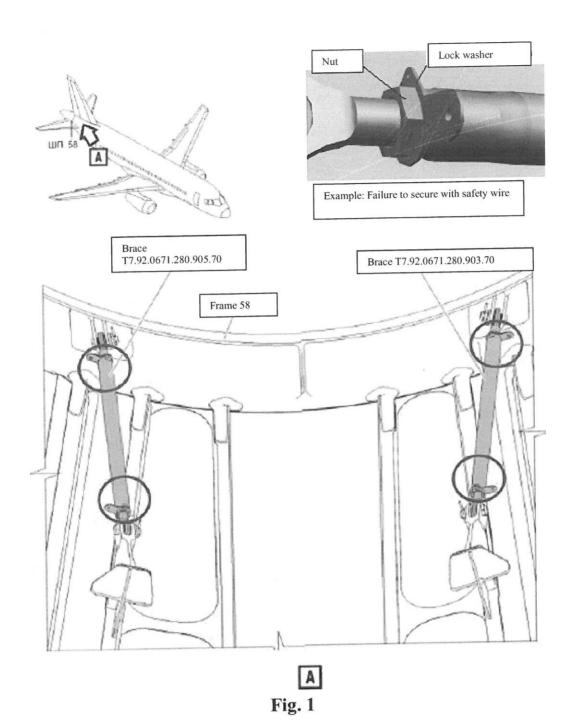
During the production on aeroplanes RRJ-95 the absence of lock of nuts and lock washers of longitudinal strut rods T7.92.0671.280.905.70/B and T7.92.0671.280.903.70/B by locking wire installed between frames 57 and 58 (Section F5) was detected. This discrepancy can lead to misalignment of the rods and subsequent damage to the longitudinal struts.

- 1. For RRJ-95 aeroplanes Serial Numbers: 95175, 95177, 95179 95185 within 8 days from the date of publication of this Technical Decision to perform the one-time inspection of the longitudinal strut rods T7.92.0671.280.905.70/B, T7.92.0671.280.903.70/B (Fig. 1) for the presence of locking nuts and lock washers with a locking wire in accordance with AMM 53-83-00-220-802 (paragraphs 3.5):

- 1.1. In the presence of locking with a safety wire, no action is required;
 - 1.2. If there is no locking with a safety wire, check that the nuts do not turn (there is a gap between the nut and the lock washer):

- a) If there is no turning of the nuts, lock the nuts and lock washers with a locking wire in accordance with AMM 20-11-02-910-804 (fulfillment 5);
 - b) If there is any turning of the nuts, send a Technical Request to the RRJ-95 aeroplane developer for recommendations on how to eliminate the discrepancy.
