## AIRWORTHINESS DIRECTIVE

No. 2020-FATA-01020A-03

Applicability – RRJ-95 aircraft

### **TECHNICAL DECISION RRJ0000-OR-470-4159**

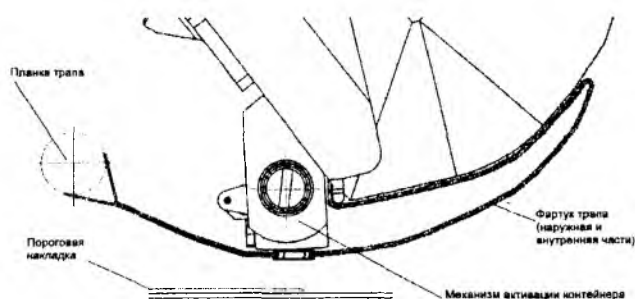
Figure 1 – The correct position of the apron of the slide

6. Make sure that the inside of the apron of the slide is in the right position, as shown in Figure 1. In the case of the wrong position of the apron (Figure 2) lay it according to Figure 1:

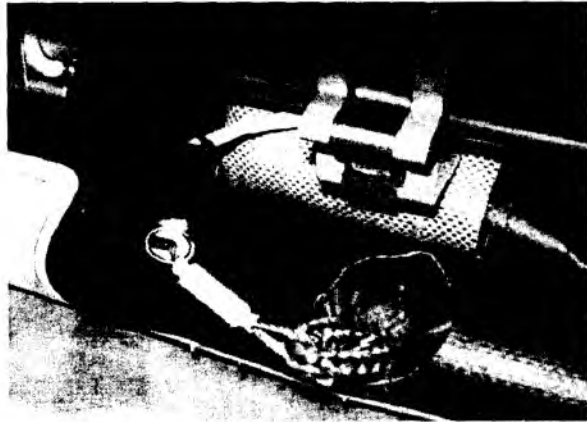
Figure 3 – The correct position of connector

8. Control the position of the quick-disconnect connector. Make sure the connector of the quick-disconnect is placed closer to the board away from the opening mechanism, as shown in Figure 3:
