AIRWORTHINESS DIRECTIVE

Ref. No. 2019-322-03

Applicability – RRJ-95 aircraft

Pursuant to revealing of the slat section track link crack on RRJ-95 aircraft,

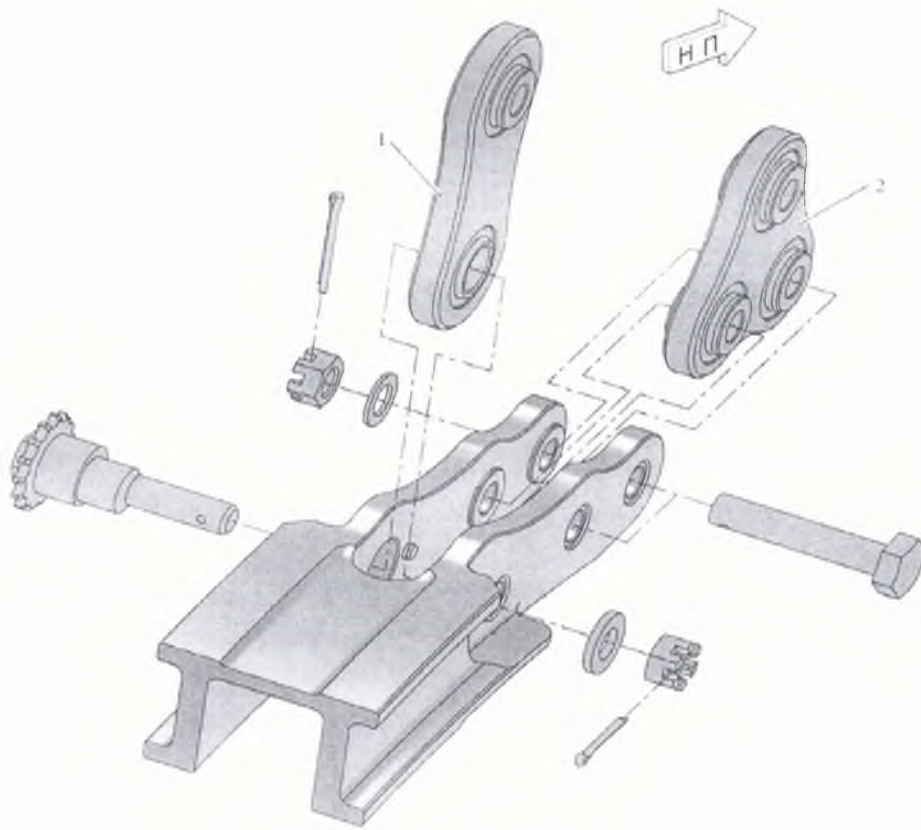
1. Starting from 15.06.2019, during the weekly WY-Check/8 DY on A/C RRJ-95 MSN 95030, 95037 and from 95116 to 95220, to perform the inspections of links of tracks (See. Fig.1 (it. 1, 2) and Fig.2 (it. 3) and bearings of links of track of sections 2, 3 and 4 of slat of LH and RH outer wings in accordance with the provisions of p. 4. Б. (2) and (6) of AMM Tasks No. 57-43-00-220-802, 57-44-00-220-802 and 57-45-00-220-802, until the implementation of SB No. RRJ-57-00451-BD “Wing – Replacement of link of track of slat section” (Planned release date of the SB – 23.05.2019г.)

2. In case of finding a crack of link of track and/or deterioration and press-out of the bearing of link of track of sections 2, 3 and 4 of slat of LH and RH outer wings following the results of implementation of p.1 hereof, it is necessary to replace the damaged track link assembly (track link and bearing), according to the identification information in Table 1 and under the instructions given in AMM Tasks No. 57-43-00-900-804, 57-44-00-900-804 and 57-45-00-900-804

Once the track link assembly is replaced, continue the inspections of the track links (See Fig.1 (items 1, 2) and Fig.2 (item 3) and the bearings of links of track of sections 2, 3 and 4 of slat of LH and RH outer wings during the weekly WY-Check/8 DY in accordance with the provisions of p.1 hereof and subject to the following conditions:
