## AIRWORTHINESS DIRECTIVE

No. 2020-FATA-01020A-03

Applicability – RRJ-95 aircraft

### **TECHNICAL DECISION RRJ0000-OR-470-4159**

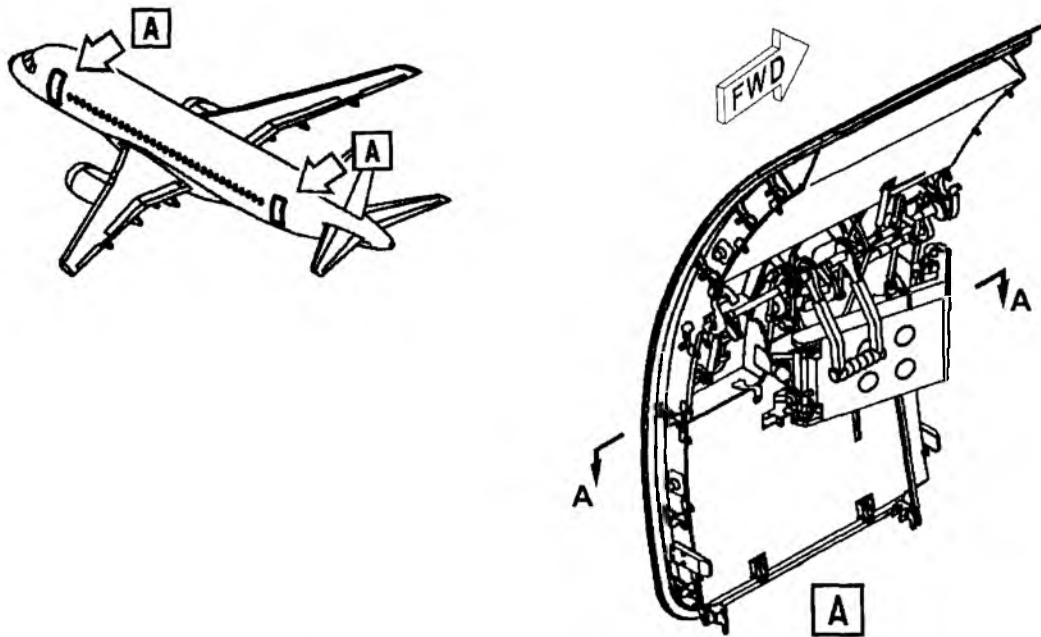
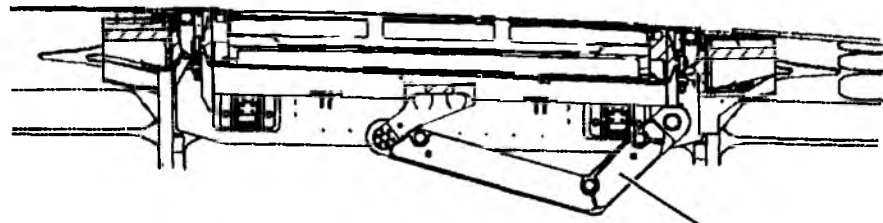
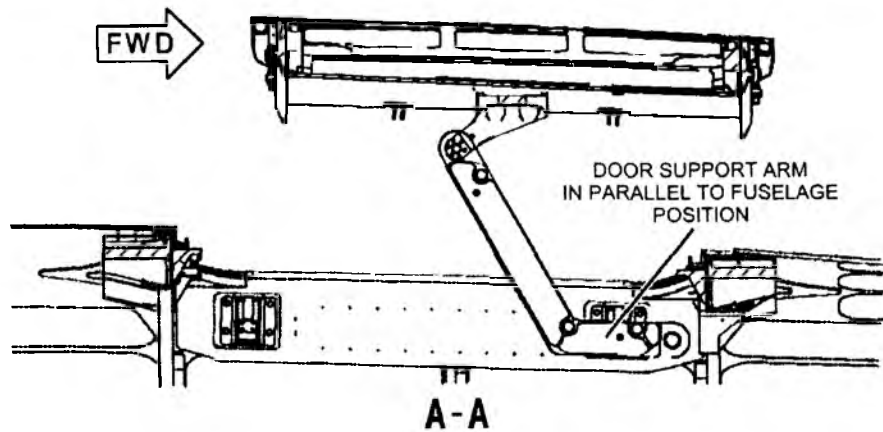
Operational Test of the Damper of the Emergency Power Assist System of the Forward (Aft) Entry Door  
Figure 501

**NOTE:** When you open the door, the hydraulic fluid flow sound inside the damper of the EPAS is usual. Other unwanted sounds (dry friction, crunching, clanking, squeaking, cracking) are not permitted.

- (1) Open the forward (aft) entry door from the inside (*Ref. Task 52-10-00-010-801, Steps 4A(1)–4A(5)*).
- (2) Move the forward (aft) entry door forward suddenly for a maximum of 1 s to release it from the fuselage. Before the support arm (*Ref. Fig. 501*) is parallel to the fuselage, make sure that the door speed decreases and the force for its movement suddenly increases.
- (3) Pull the forward (aft) entry door at the internal handle and bring it closer to the door frame.
- (4) Do the Steps (2) and (3) again five times.

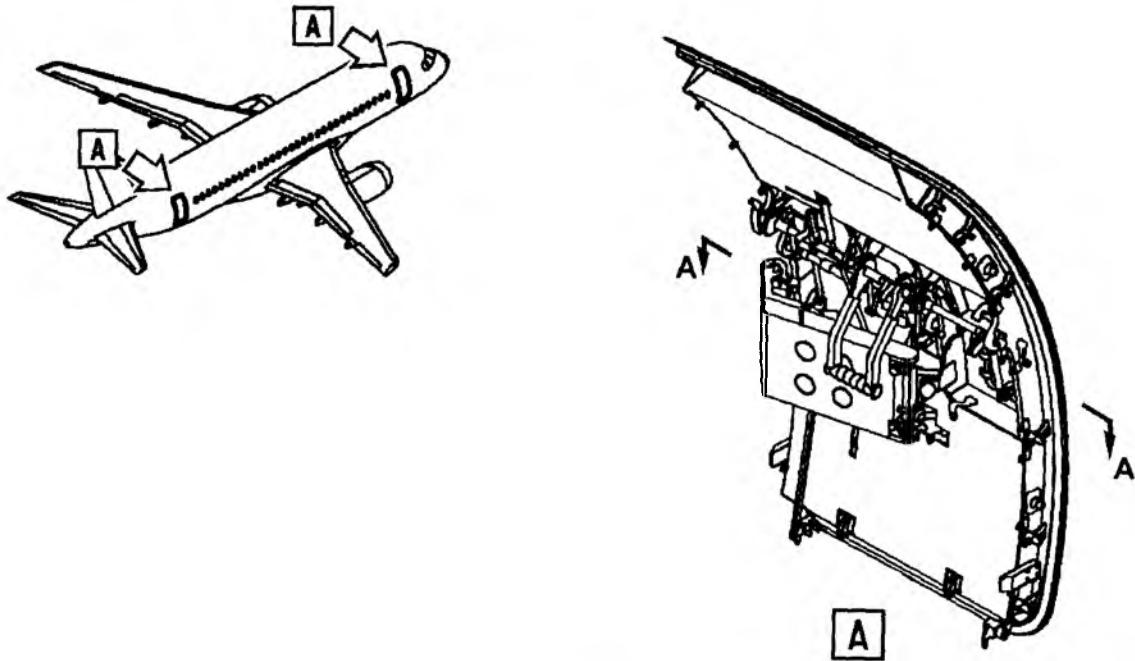
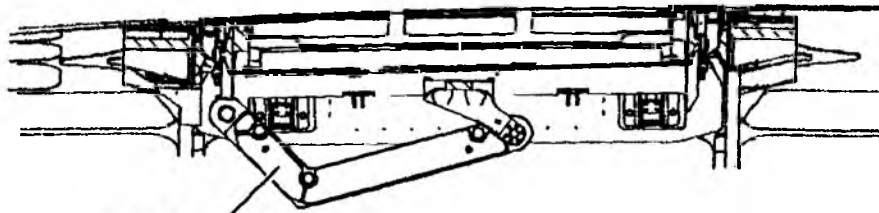
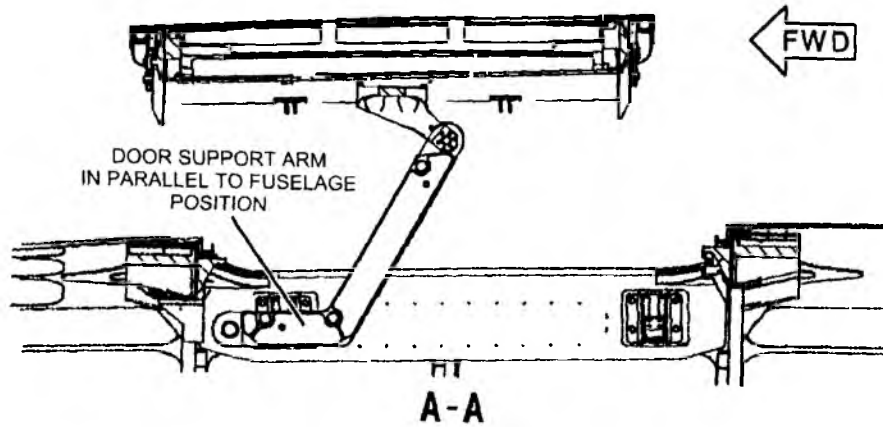
Operational Test of the Damper of the Emergency Power Assist System of the Forward (Aft) Service Door  
Figure 501

**NOTE:** When you open the door, the hydraulic fluid flow sound inside the damper of the EPAS is usual. Other unwanted sounds (*dry friction, crunching, clanking, squeaking, cracking*) are not permitted.

- (1) Open the forward (aft) service door from the inside (**Ref. Task 52-10-00-010-801, Steps 4A(1)–4A(5)**).
- (2) Move the forward (aft) service door forward suddenly for a maximum of 1 s to release it from the fuselage. Before the support arm (**Ref. Fig. 501**) is parallel to the fuselage, make sure that the door speed decreases and the force for its movement suddenly increases.
- (3) Pull the forward (aft) service door at the internal handle and bring it closer to the door frame.
- (4) Do the Steps (2) and (3) again five times.
