SLAT SECTION 2 — INSPECTION/CHECK

***Figure 602: CHANGED **TASK 57-43-00-220-802**

Detailed Inspection of the Slat Section 2 Tracks 3, 4, and 5

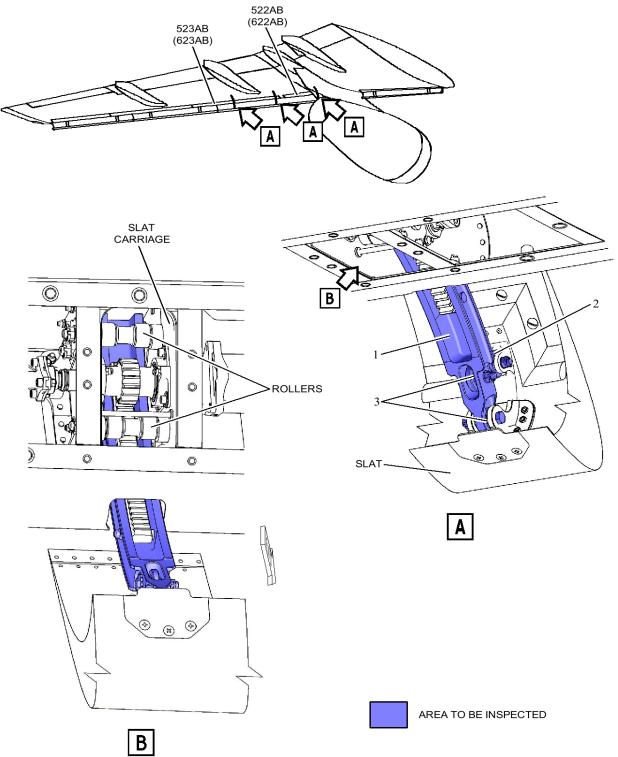
Detailed Inspection of the Slat Section 2 Tracks 3, 4, and 5 Figure 601

A. (Ref. Fig. 601)

- (1) If required, clean the inspected surface by the cleaning rags NP-008 wetted with ST-004 solvent.
- B. Detailed Inspection of the Slat Section 2 Tracks 3, 4, and 5
 - Inspect the tracks (1). Make sure that there are no mechanical damages (nicks, chips, scratches), attritions, cracks and residual deformations. During inspection pay special attention to the working surfaces of the tracks flanges.

Inspect the links of the tracks (2). Make sure that there are no mechanical damages (nicks, chips, scratches), attritions, cracks and residual deformations.

- (3) Inspect the stop (only on the track 4). Make sure that there are no mechanical damages (nicks, chips, scratches, cracks). Make sure that the stop attachment to the track is not loose.
 - NOTE: If any defects are detected, eliminate them, (Ref. SRM).
- (4) Make sure that there are no corrosion damages and defects of the paint coating on the surface of the tracks (1), links (2) and stop.
- Inspect the visible parts of the bolted and riveted joints. Make sure that they are not loose, are locked with cotter pins, have no corrosion damages and defects of the paint coating.
- Inspect the bearings (3). (6)
 - NOTES: 1. The bearing breakage and its pushing out is not permitted.
 - 2. if the mechanical damages (nicks, chips, scratches, cracks) is detected, write to the Manufacture.

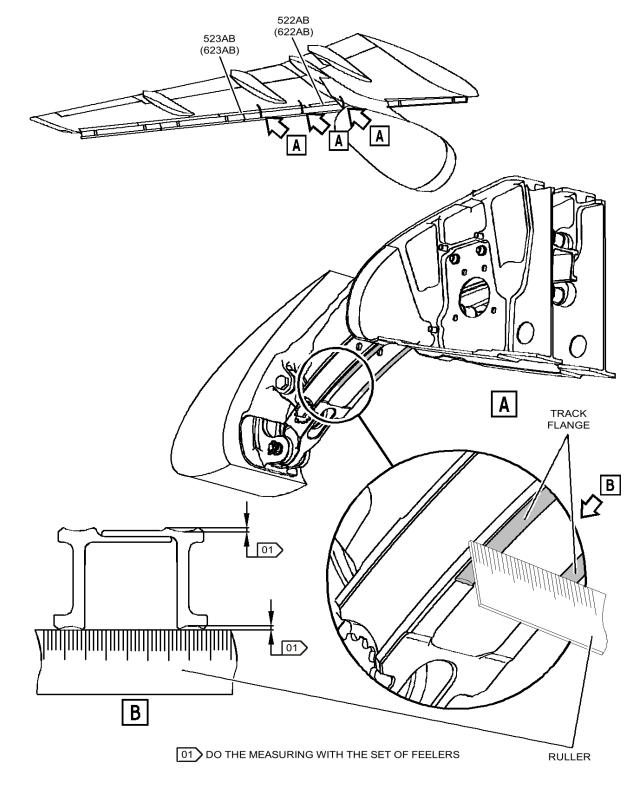
Measuring of the track wear Figure 602

NOTE: Permitted wear of the working surfaces of the track flanges under the bearing and support rollers in the form of the smooth groove is not more than 0.2 mm (0.008 in). Permitted wear of the working surfaces of the tracks under the bearing and support rollers in the places. which correspond to the extended and retracted position of the slat, is not more than 0.3 mm (0.01 in).

Do the measurement with the set of feelers 0.05 mm (0.002 in) – 0.3 mm (0.01 in) and the metalic ruller [lenght is not more then 100 mm (3.93 in)] on the upper and lower track flanges. Measure the gap between the edge of the metal ruler and the wear on the track surface.

Measure the gaps only in the front part of the track in about 20 mm (0.78 in) distance from the contact point of the front lower support rollers Apply a ruler across the working surface of the track perpendicular to its surface (ref. Fig. 602).
